STUDY ON PERFORMANCE OF STEEL MOMENT-RESISTING FRAMES SUBJECTED TO MULTIPLE EARTHQUAKES

Randy Tenderan

**AARGI WEBINAR
ON EARTHQUAKE
ENGINEERING**

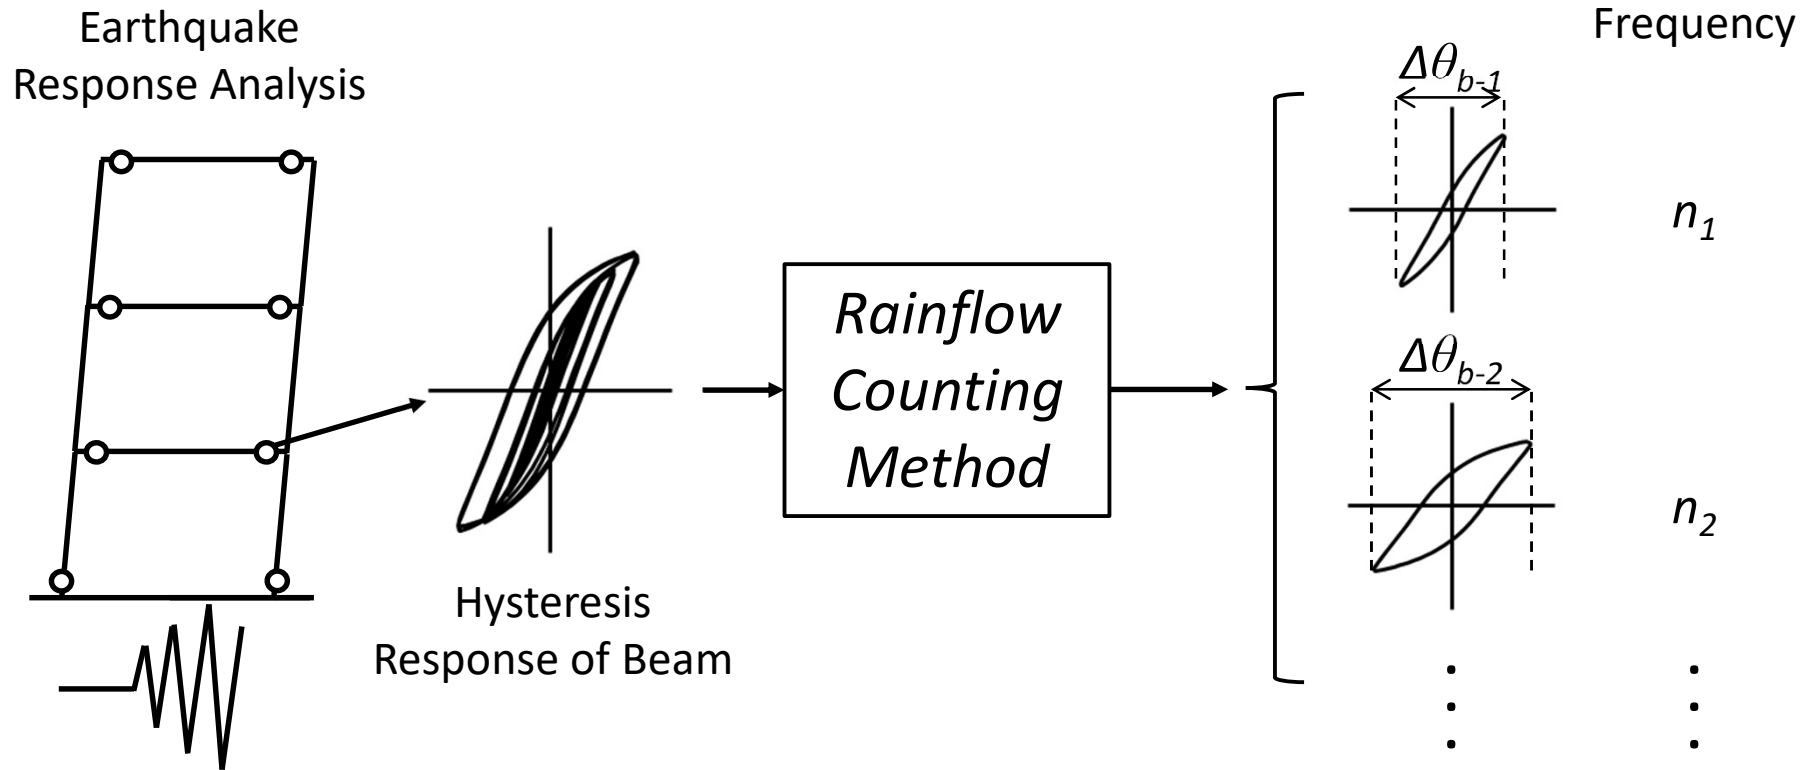
Cumulative Damage of Beam

Miner's Rule: Cumulative Damage, $D = \sum_{i=1}^k \frac{n_i}{N_{fi}}$

$D \geq 1.0 \rightarrow$ Beam is estimated to be fractured

$N_f =$ The number of cycles to failure*

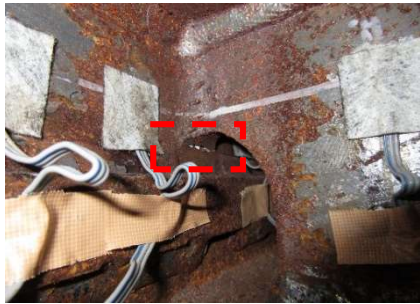
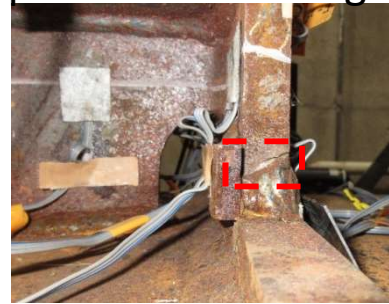
1st specimen

16th set: crack initiated

23rd set: crack almost penetrated through

28th set: fully fractured

$D_{calc.}$

99.1%

The **reliability** of the cumulative damage evaluation method under random loading is **acceptable**

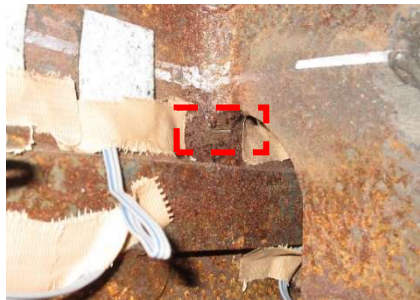
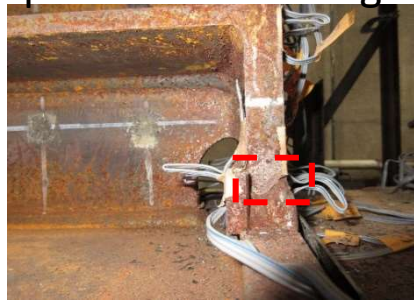
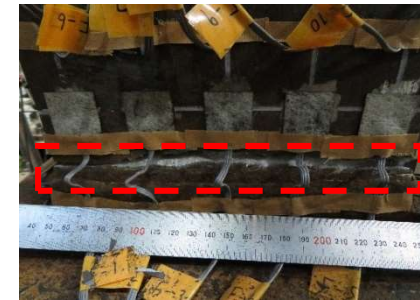
2nd specimen

10th set: crack initiated

17th set: crack almost penetrated through

19th set: fully fractured

87.6%

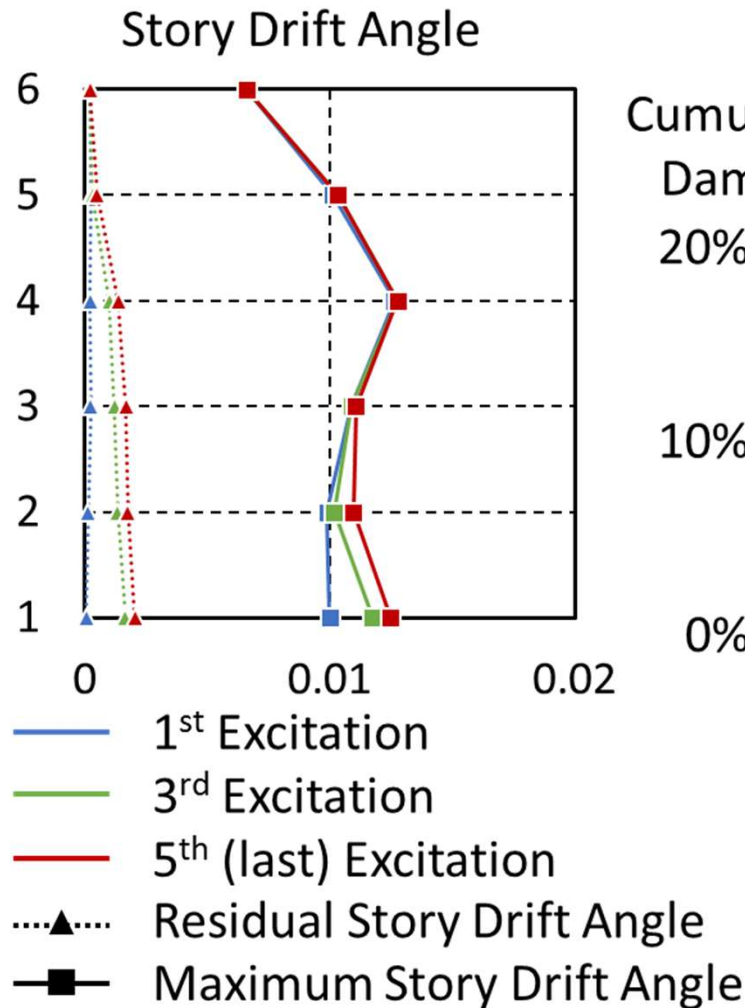
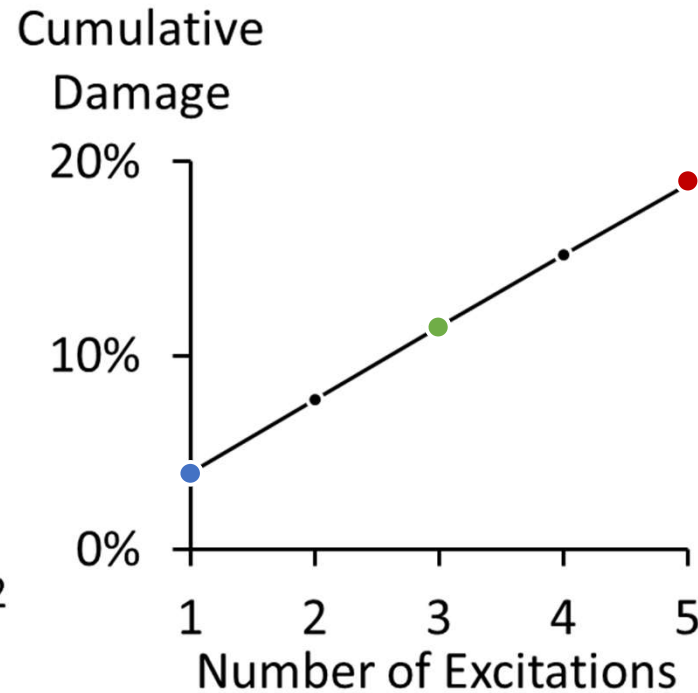
Analytical Result: PGV 0.5 m/s

Stable Behavior

6-story Strong Col. Base Model Excited by JMA Sendai NS Record

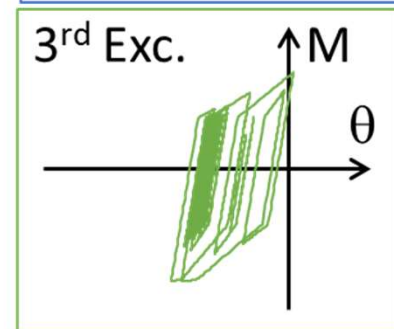
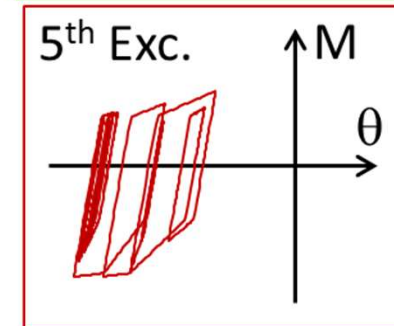
Analytical Result: PGV 0.75 & 1.0 m/s Ductile Fracture

6-story Strong Col. Base Model Excited by PGV 1.0 m/s Hachinohe EW Record

- Maximum Story Drift Angle
- ...▲... Residual Story Drift Angle
- 5th (last) Excitation
- 3rd Excitation
- 1st Excitation

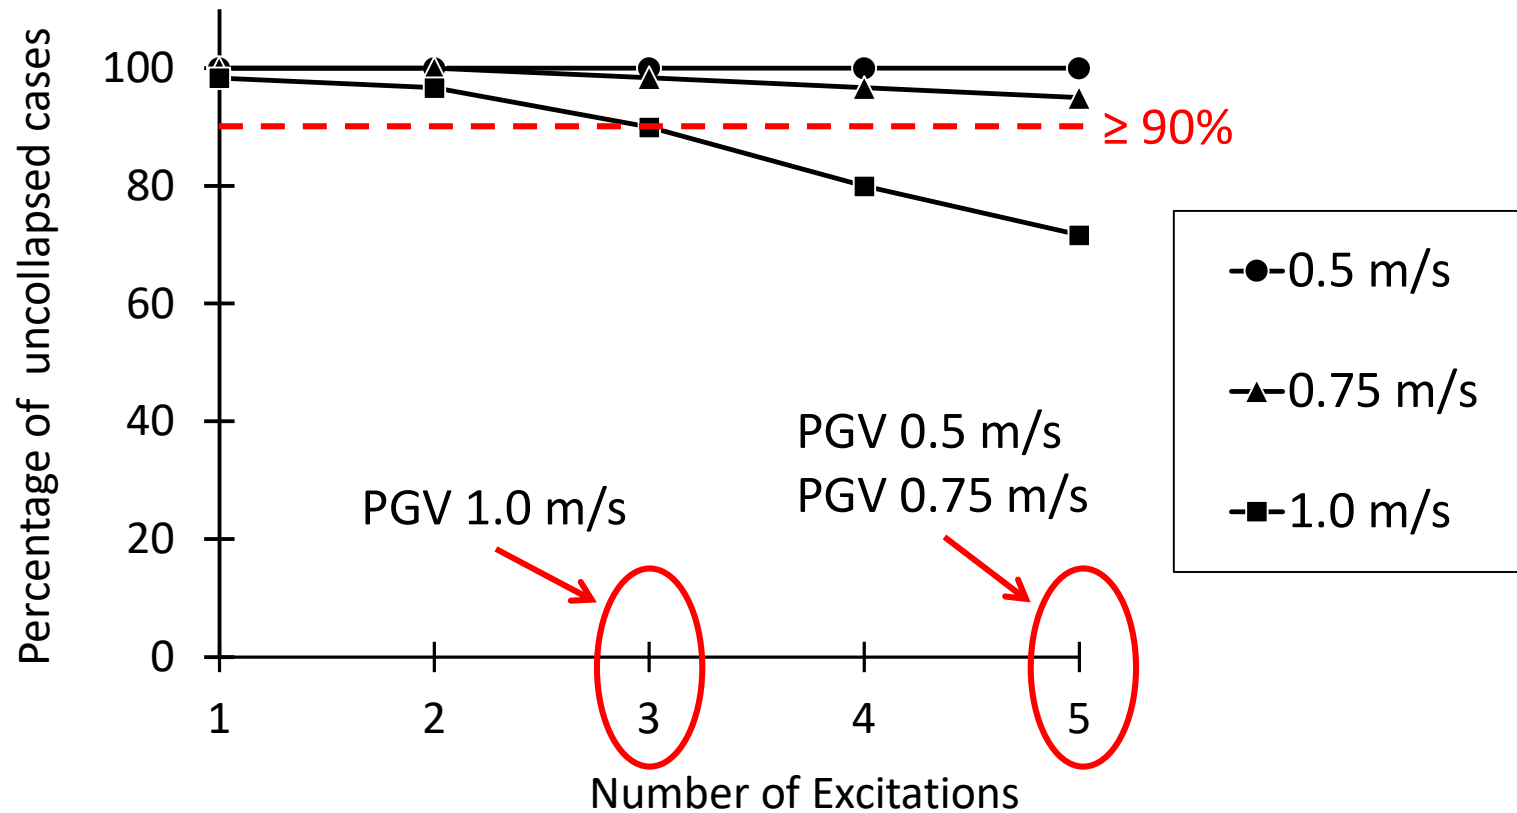
Collapse Fragility

6 different models x 10 different ground motion seq. = 60 cases

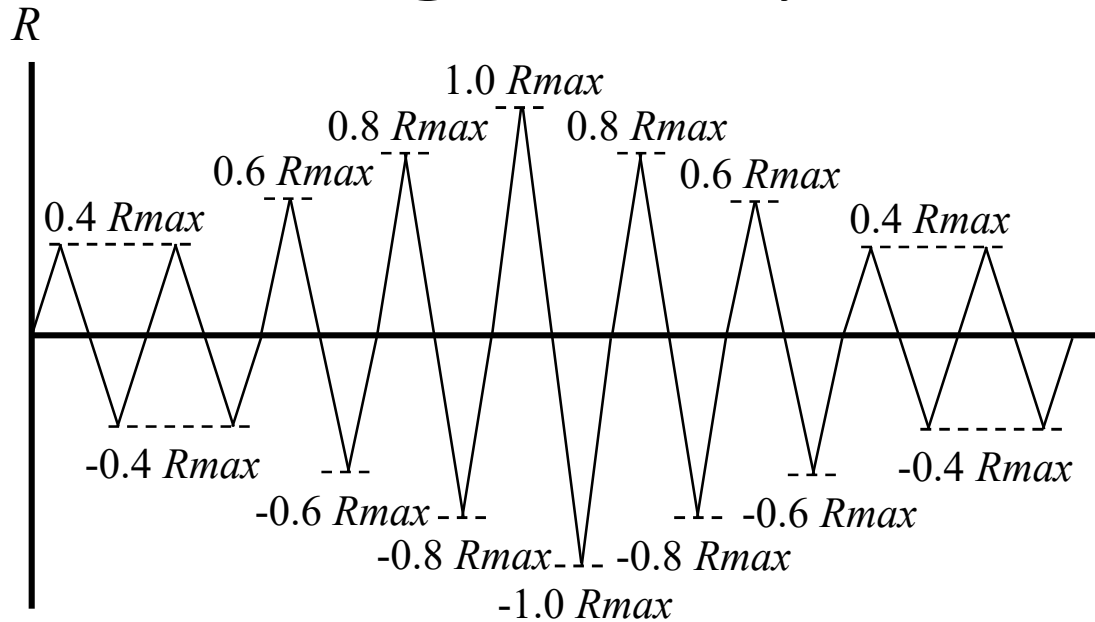
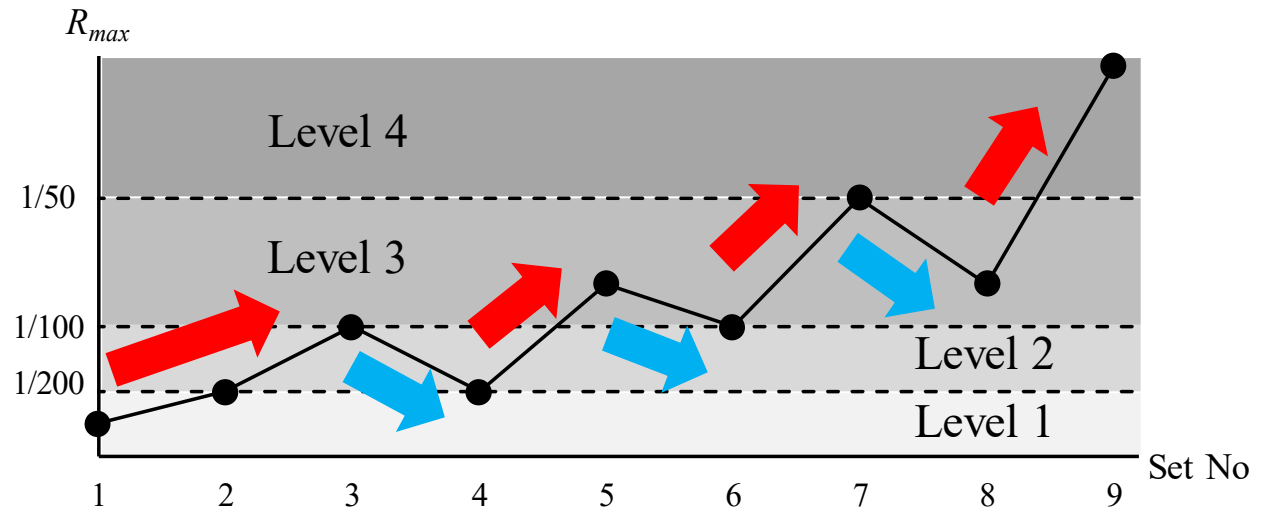
Loading History

Typical **one set** of loading represents **one earthquake**

Nine sets of loading with **various levels**

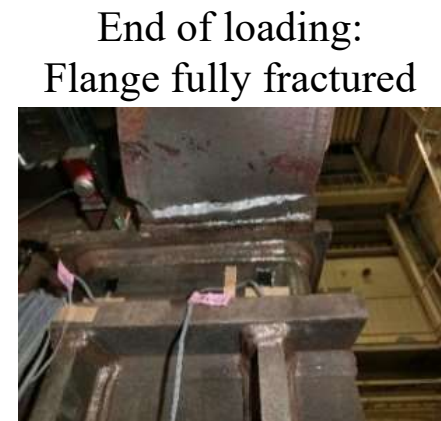
2nd specimen (ALC)

Set 2	Set 3	Set 4	Set 5	Set 6	Set 7	Set 8	Set 9	Const
1/200	1/100	1/200	1/75	1/100	1/50	1/75	1/33	(1/50)

Yielded | Local buckling | Crack initiated | ALC panel cracked | Crack penetrated
